IDENTIFICATION OF FLOOD HAZARD RESULTING  
FROM AUFEIS FORMATION IN AN  
INTERIOR ALASKAN STREAM

An Information and Evaluation Report prepared for the Soil Conservation Service as part of a feasibility study to evaluate the utility of LANDSAT imagery for flood hazard analysis and consequent land-use decisions.

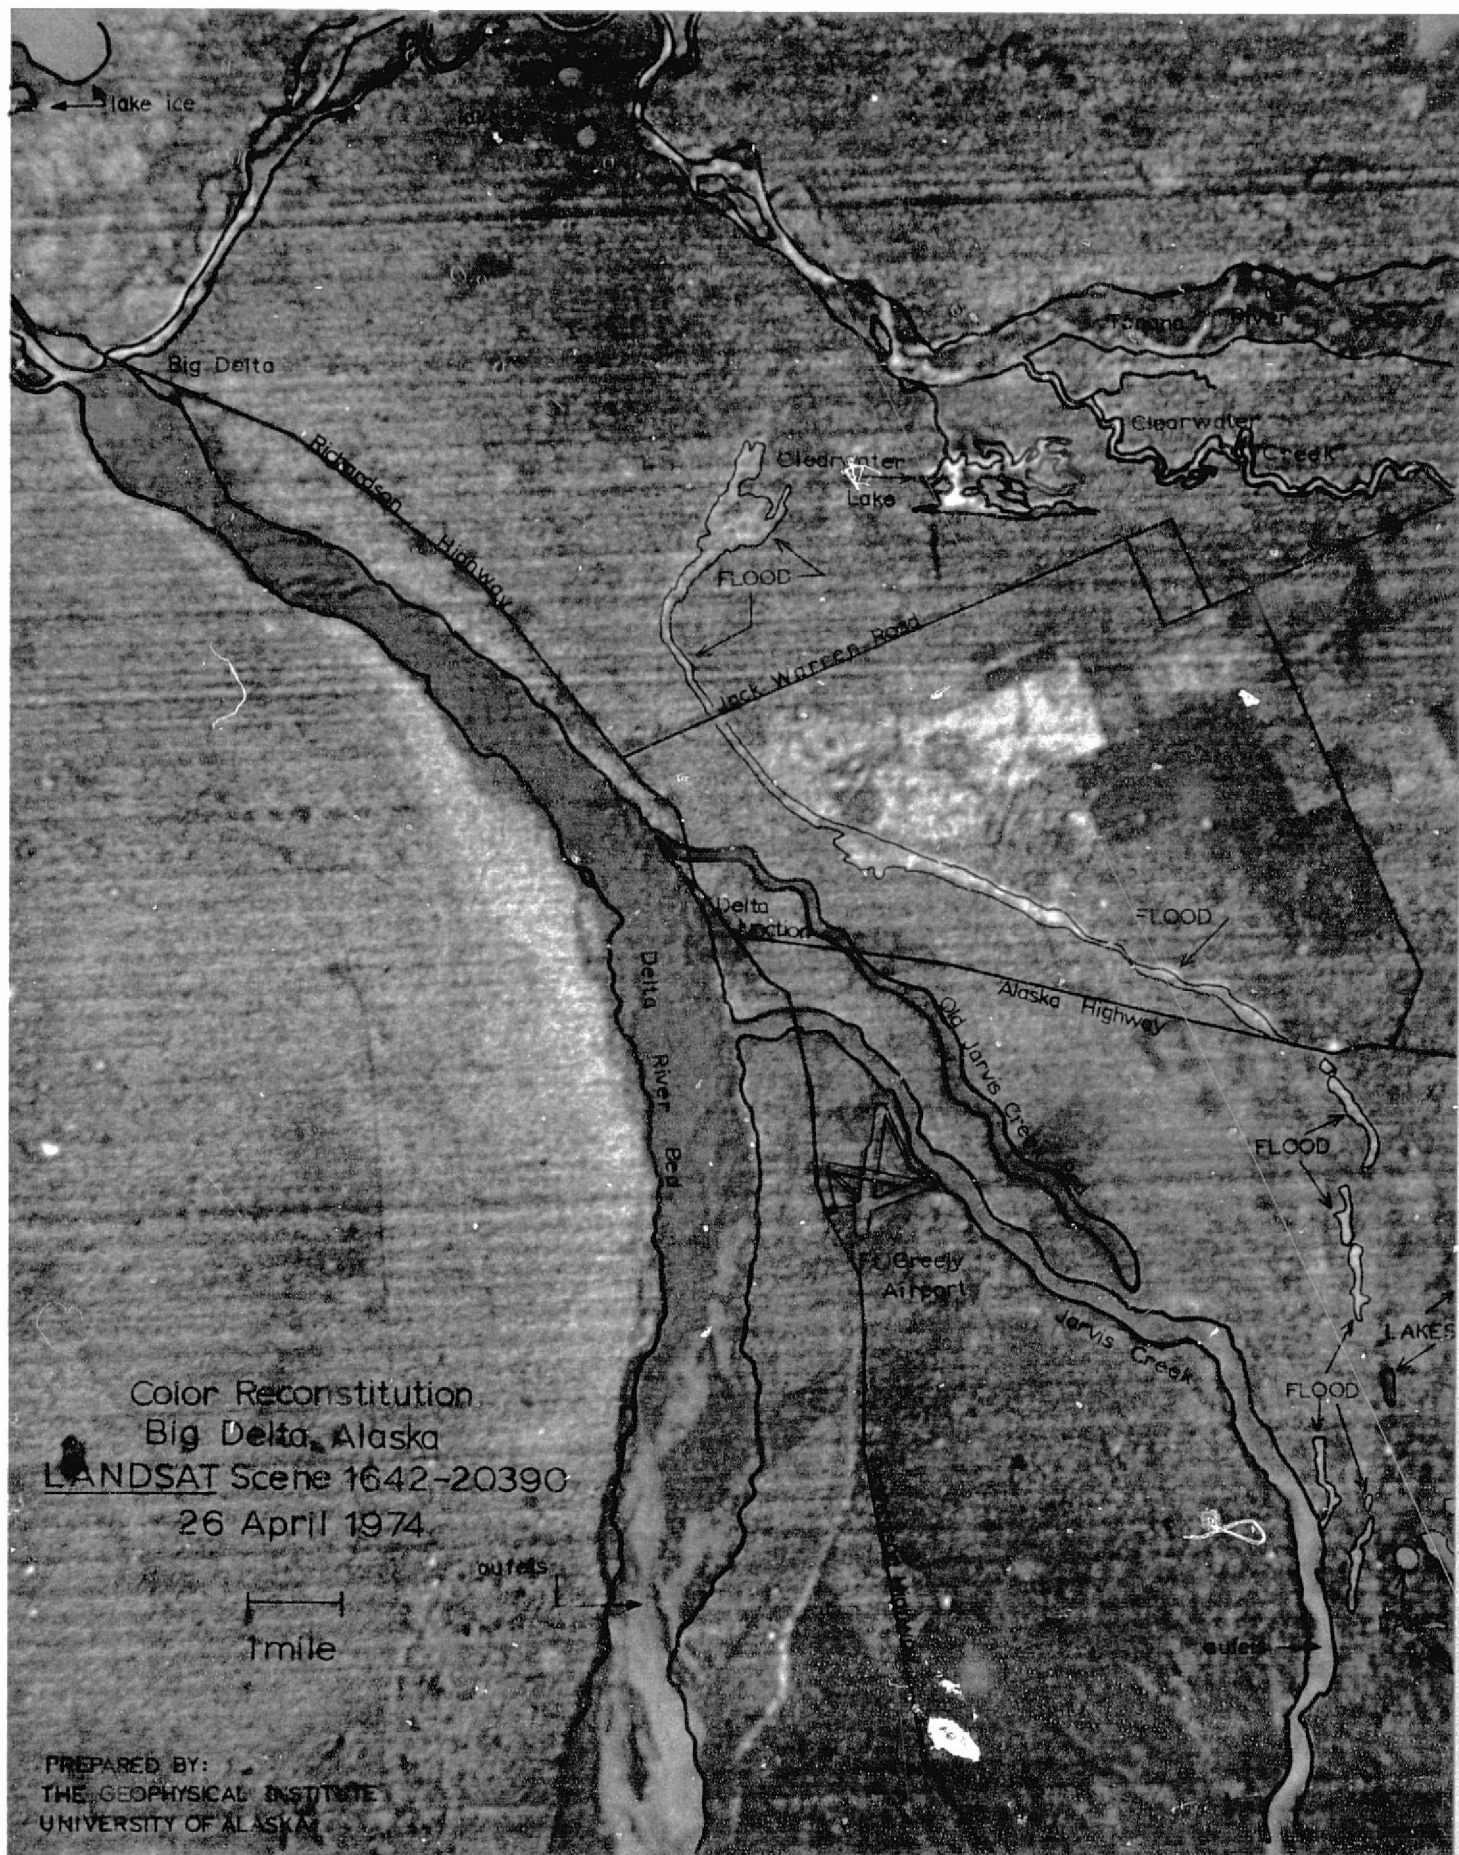
Figure 2 shows the multispectral data product used to map aufeis and flooding in the Big Delta area. For aid in identifying locations, several cultural features have been transferred to this product from

standard maps. Aufeis can be identified on both Jarvis Creek and the Delta River as red while the snow-free bare river beds below these ice formations appear brown. Several ice-covered lakes and ice pans on the Tanana River also appear red.

Water and forests appear various shades of green. The flooding waters have been delineated on this product and it can be seen that the distinction between these two features was clean everywhere except for one location. Here, topographic and vegetational data was used to distinguish between the flood waters and adjacent forest. Only areas that could clearly be identified as flooded were delineated. The problem of linking these areas with flowing floodwaters is addressed below.

Although the flooded areas could be partially identified on LANDSAT band 7 images, the identification was somewhat ambiguous. In order to produce a data product of more utility, a multi-spectral approach was taken. After considerable experimentation, it was found that clearest distinction between features of interest could be obtained using imagery from two of the LANDSAT sensors. The technique used combined data from these two sensors by simultaneously projecting data from the two wavelength bands through colored filters onto a screen.\* Band 5 (positive transparency) was projected as green, band 7 (positive transparency) as red and band 7 (negative transparency) as white. The resulting colors of surface objects had no relationship to their true colors, however, the flooded area could be distinguished as light green while bare river beds were brown and ice (including aufeis) red. This combination of projected images was photographed and enlarged to one-inch-to-the-mile scale, and is reproduced here at approximately half that scale.

At the time of this reconnaissance, the flooding could be followed from the point of diversion to and beyond the Alaska Highway. Generally, the flood waters follow tree-lined stream channels between these two points, spreading out occasionally to fill low areas. Thus it is possible for the flood waters to be confined within the narrow stream channels for portions of their path, escaping detection by LANDSAT because the width of these channels is too small to be detected by the sensors on the satellite. This explains why the flood cannot be followed continuously on Figure 2 from the point of diversion to the highway.

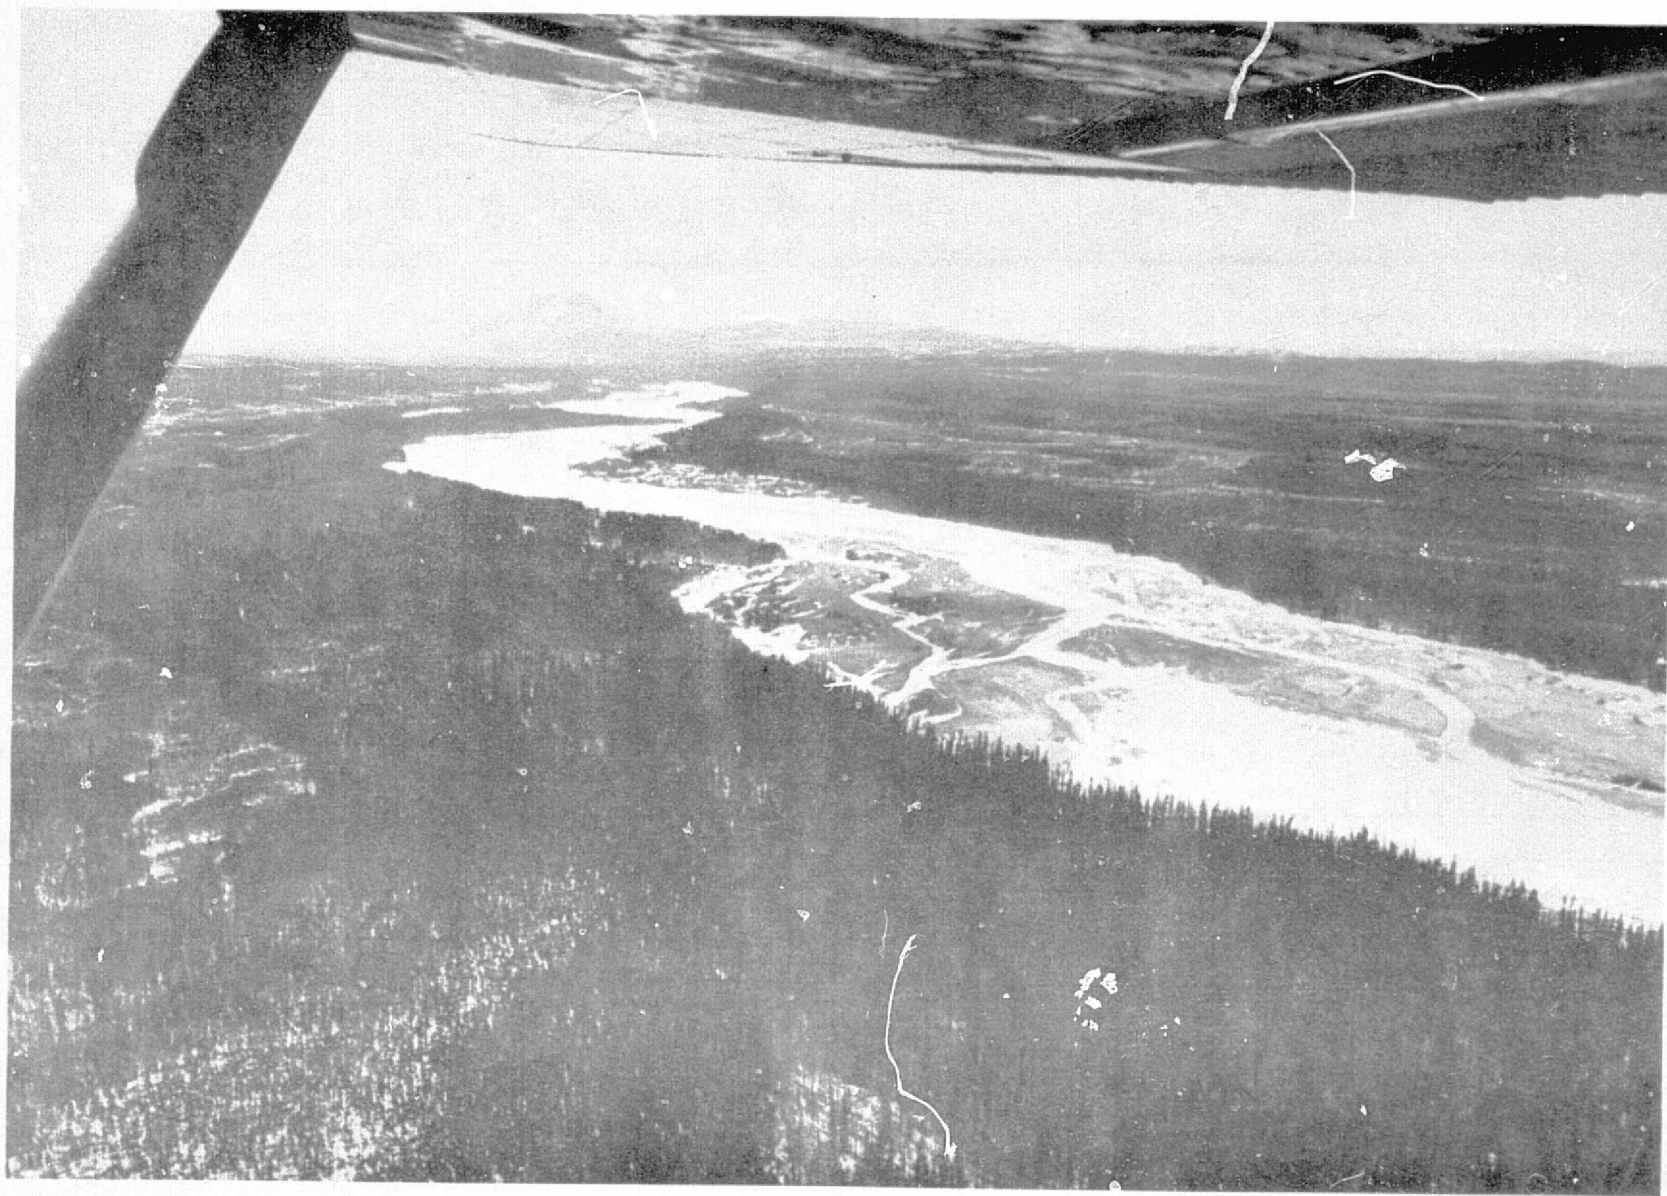
Figure 3. Oblique aerial photograph showing lower (north) end of Jarvis Creek aufeis formation. Diversion of Jarvis Creek waters takes place toward the left at the left extreme of Jarvis Creek in this photograph.

Figure 3 shows the lower (north) end of the aufeis formation on Jarvis Creek. The actual stream diversion (toward the left) takes place at the location seen approximately in the center of the photograph. Figure 4 shows the bank-full ice conditions at the point of overflow.

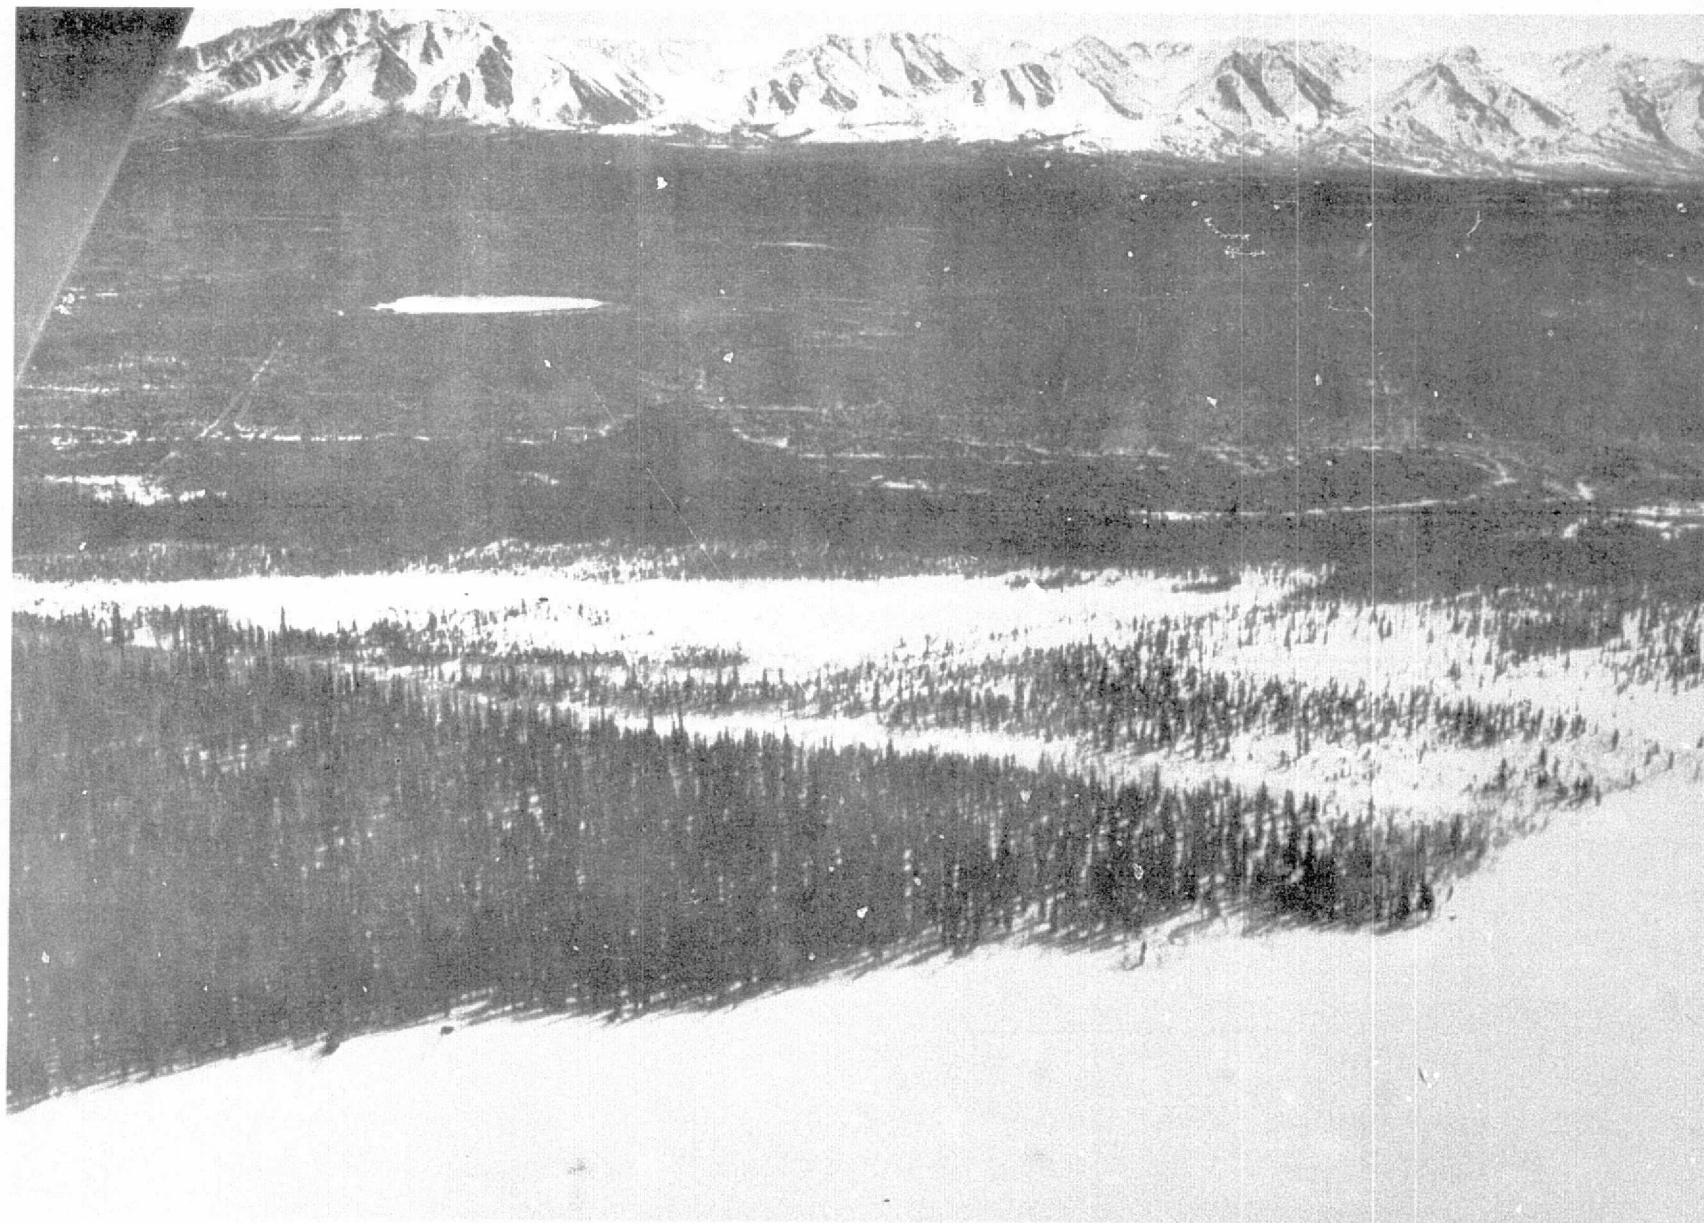
Figure 4. Oblique aerial photograph showing bank-full ice conditions in region of actual overflow.
